Monitoring Data Record

Project Title: R-3415 NC 67 Widening COE Action ID: 200520314
Stream Name: Williams Creek & UT Williams Creek (Site 3) DWQ Number: 05-0061
City, County and other Location Information: NC 67 3.2 miles west of Boonville and just west of
Haley Road (Sta. 141+50 -L- LT. and 143+00 -L- LT.); Yadkin county
Date Construction Completed: Streambank repairs completed in June 2010
Monitoring Year: (1) of 3
Ecoregion: _____ 8 digit HUC unit 03040101
USGS Quad Name and Coordinates: N 36 14' 26" W 80 45' 52"

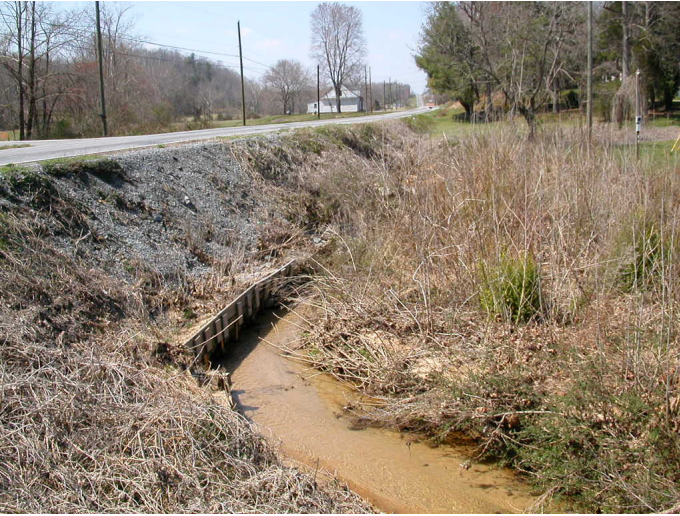
Before construction photo looking downstream

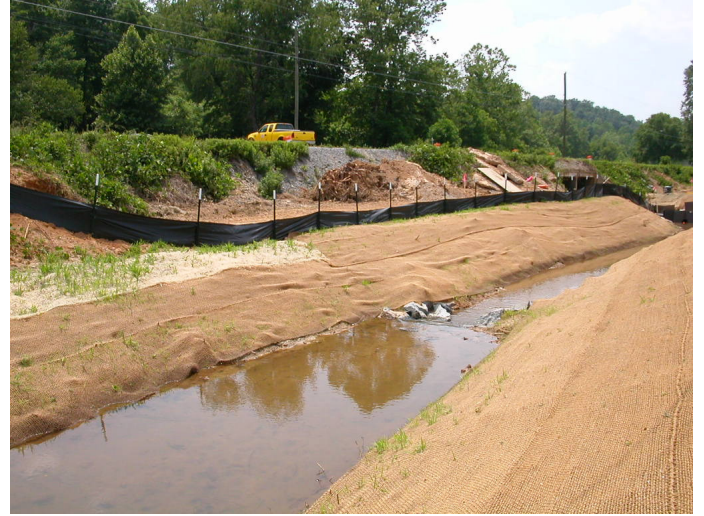
After construction photo looking downstream

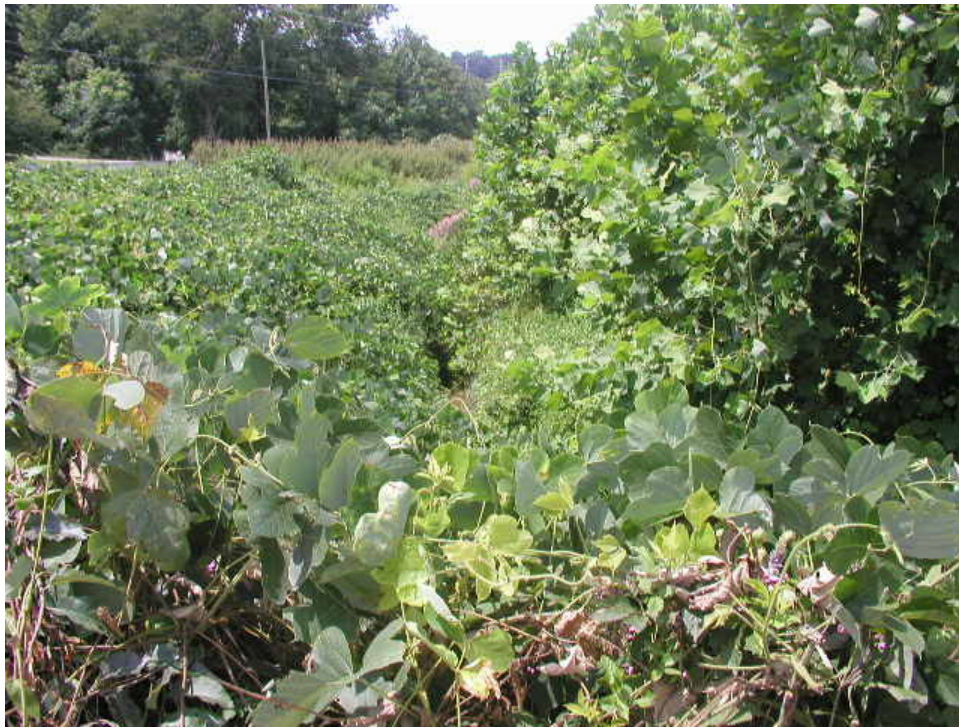
ADDITIONAL COMMENTS: Planted vegetation noted surviving included black willow, silky dogwood, and sycamore. Other vegetation noted included woolgrass, alder, and kudzu. Both Williams Creek and UT Williams Creek are covered with kudzu as seen in the August 16, 2011 photos, but these stream relocations were covered with kudzu prior to construction.

Williams Creek and UT Williams Creek (Site 3) are stable for the Year 1 monitoring evaluation. The relocated channels have provided a more natural setting for the stream and placed it farther away from the roadway. The retaining wall and concrete slabs at Site 3 before construction have been replaced with 2:1 earthen slopes that were seeded with native grasses, matted with coir fiber, and live staked. A cross vane rock weir was also installed for channel stability. Both stream relocations were covered with kudzu prior to construction and are still covered with kudzu today but these stream relocations are more stable due to the natural channel design being implemented. NCDOT will continue to monitor these stream relocations.

Year 1 monitoring photo looking downstream (8-16-11)

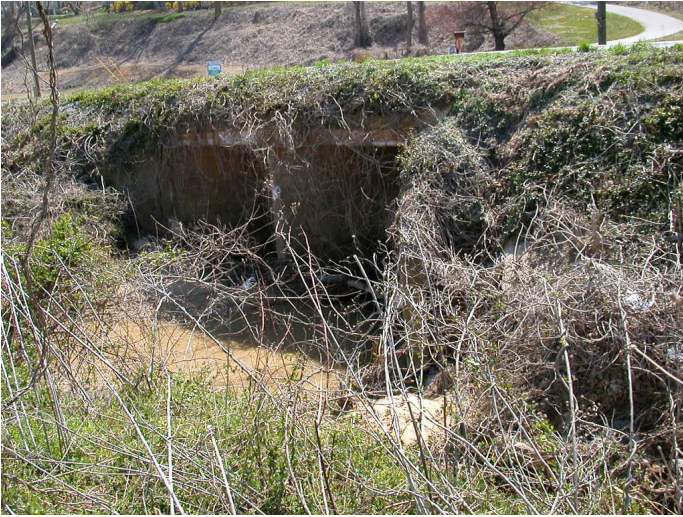
Before construction photo looking downstream

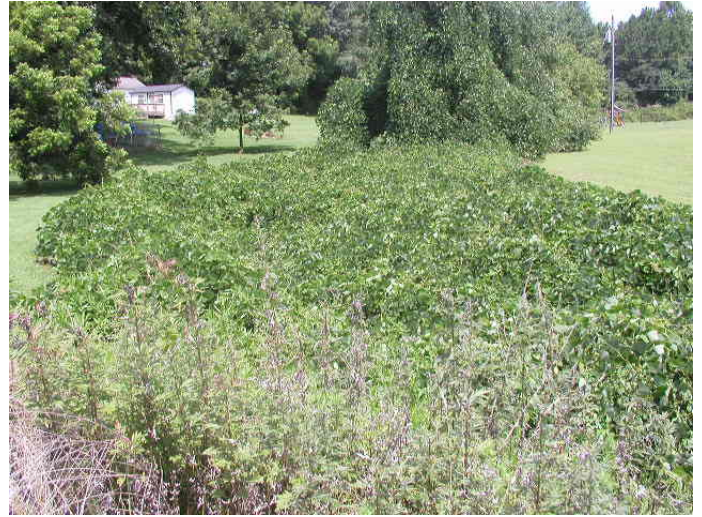
Year 1 monitoring photo looking upstream (8-16-11)
